**POST MORTEM REPORT
1Q / 2007 D&R "MAJOR" S/D**

4 CRUDE UNIT

Jan 15th – March 15th 2007

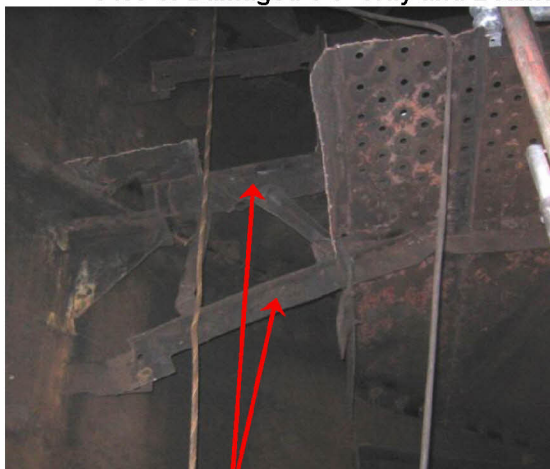
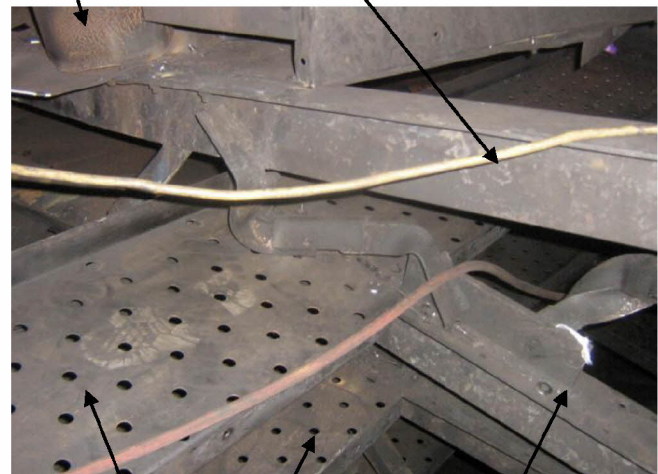
Pics of Damaged 1-5 Tray and Beams

Trays 1-5, the Collector Tray, and corresponding support trusses were found to be severely damaged. The bottom trays 1-5 were blown up into the collector tray. The Collector tray was not longer functional and looked like a ship wreck. The 6" meter pipe and two 9" over flow pipes that extend down from the sump on Tray 6 to the weir on the collector tray had been forced upward by the collector tray and damaged the tray 6 sump.

Tray 3 and 4 Truss/Beam

9" Overflow Pipe

Collector Tray Beam

Tray 5

Tray 4

Tray 5 Beam

New replacement In-Kind 410 S stainless steel trusses were purchased as a contingency and were installed. New Trusses supplied by Sulzer MR# 224766. (original trusses were by Koch).

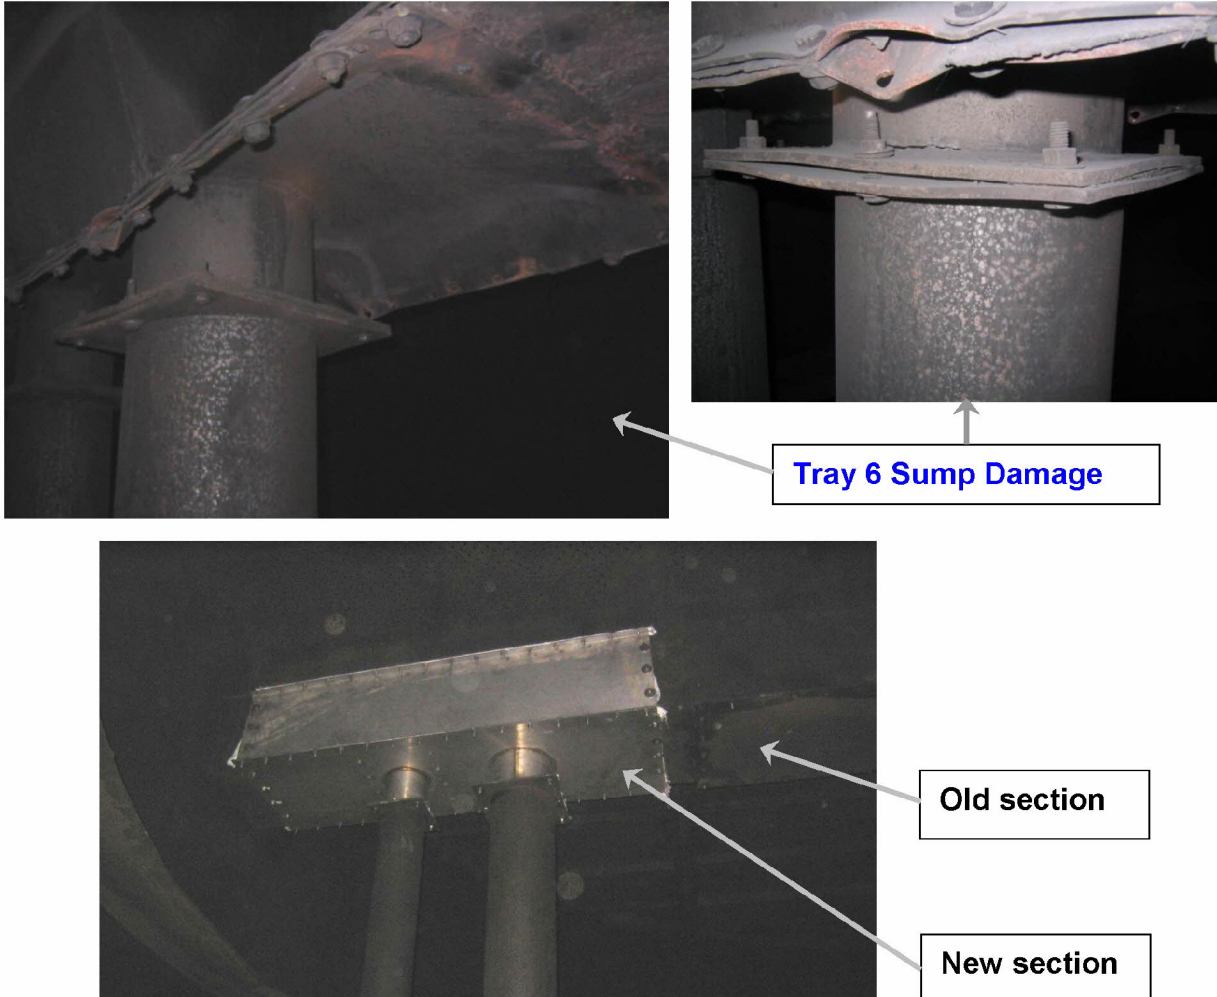
The Sump on Tray 6 needed repair due to the upset from trays 1-5 and the collector. The 6" meter pipe and two 9" over flow pipes, that extend down from the sump floor on tray 6 to the weir on the collector tray, had been forced upward by the collector tray and damaged the sump floor. The sump floor was bulge upward 3-4". The seams between the sump floor and sump walls no longer sealed and the overflow tube to sump floor weld was cracked/torn.

There are 4 sections to the sump. The two end sections were replaced and the two center sections were reused. The two end sections replaced consisted of the sump floor and sides. The floor contained the new 6" and 9" pipe connections complete with vortex breakers and metal screen.

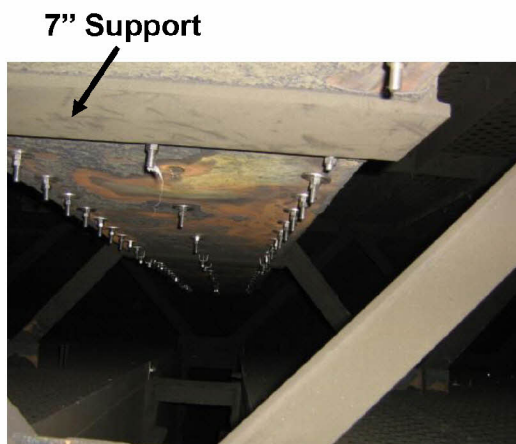
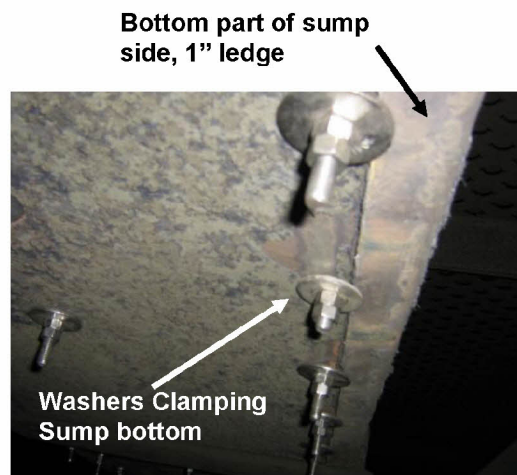
During closure of the column, corrosion was noted on the tray 25 sump (diesel cut). It appeared that the sump had not been replaced when the tray was replaced during the previous shutdown. The tray had holed through in numerous locations and was close to failure. Because the discovery occurred during closure, there was not enough time to order replacement parts. A repair was made by installing 10 gauge 410 SS plate to cover the sump floor. Parts were fabricated via the Boiler Shop.

Figure 1 and Figure 2. View of the bottom of tray 25 sump floor after the repair.

The 410 SS repair plates were designed to run from one 7" support beam to the next and to clamp to the thicker part of the sump floor with large washers. Bolts were installed every 6" along the perimeter of the 410 SS plates and several bolts in the center of the plate. Figure 1 and Figure 2 show the underside of the sump floor. The bolts coming through the sump floor are clamped to the thicker part of the sump bottom. A 7" support beam is showed in the top of Figure 1.

Action Required: Replace sump assembly in-kind next S/D.

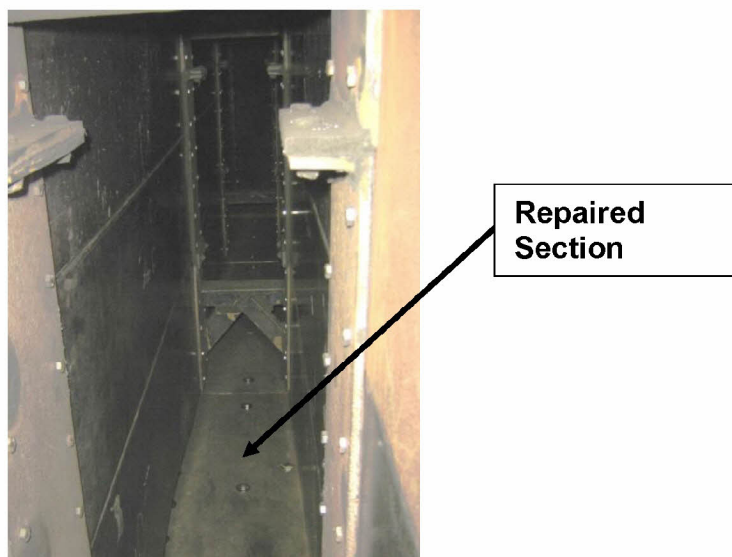
Figure 3. View of the top of tray 25 sump after repair.

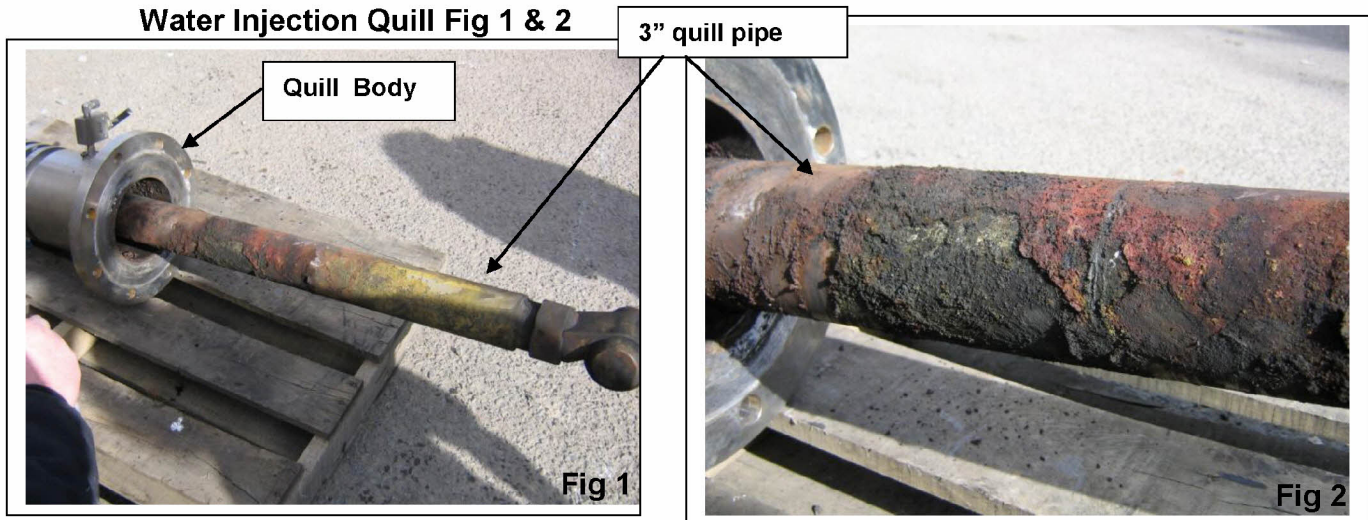
Water Injection Quill Fig 1 & 2

The water injection quill was pulled for the overhead line work. The quill was looked over by Inspections and Engineering. No issues found and no work/repairs required. There was a small amount of corrosion on the top of the 3" quill pipe that looked like snail tracks. Inspections pit gaged the corrosion at 0.020" on the 3" sch 80 pipe. This was not an issue.

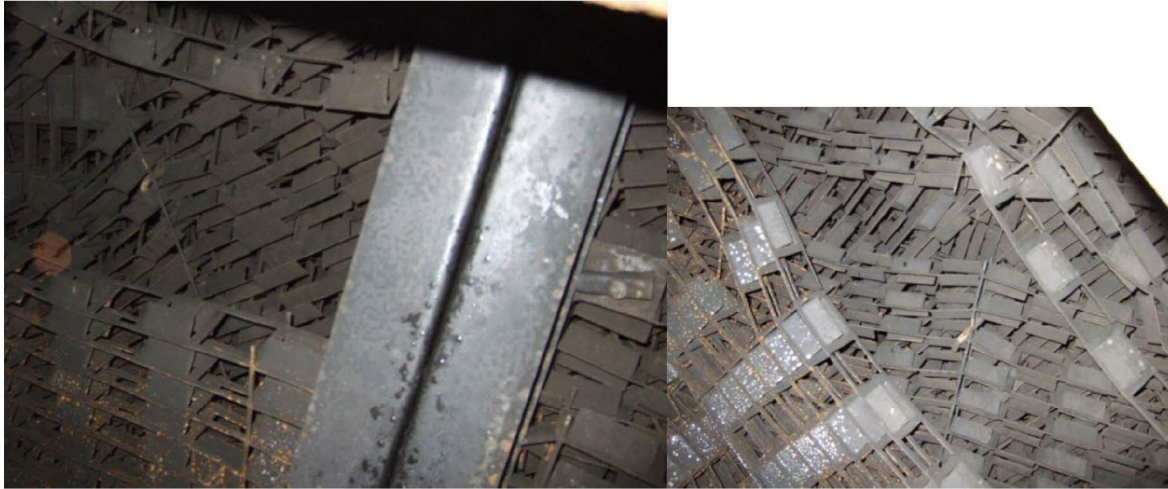
- Bottom layers of Bed were disrupted. Bed was removed to repair disrupted packing and evaluated coke deposits if any. Only minimal amounts of coke found. No excessive coke buildup.

The two pictures are the Bottom of Bed 5 Packing Looking up.

- Bed 5 was reassembled using with a combination of existing packing and all of the contingency Grid packing.
- Note: 30% of bed packing was purchased for contingency by PED.

Would evaluate/determine is a hold down is required for Bed 5 if found upset in the future. Note: was found upset in 2002 S/D.

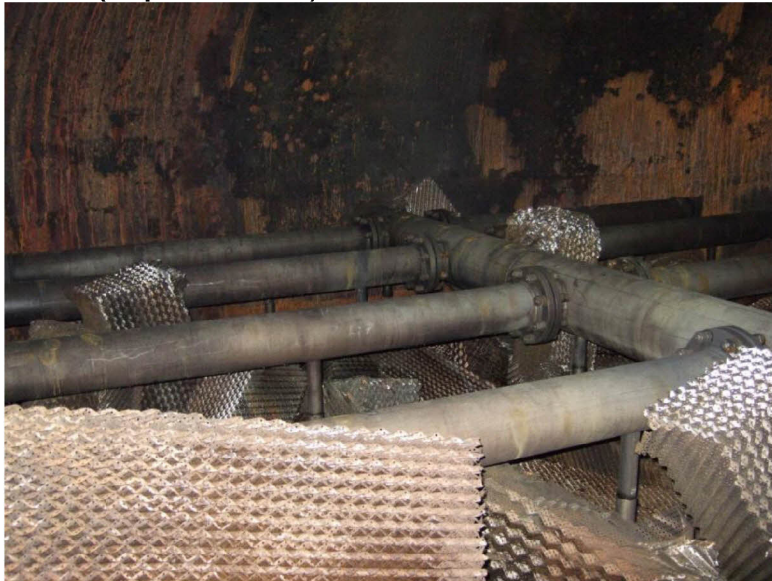
Bed 1 (Top Most Bed)

- First few layers of packing were found displaced/disrupted.
- All packing was removed and replaced with new in its entirety.
- Top of Bed 1 could benefit from a hold down for the packing. Need for hold down was eliminated since new distributor trough sits on top of the packing.
- Replaced Packing per PED. Material is ??? (Was there a reason why?)
- Bed 1 Support Ring attachment weld was blend ground all the way around to remove crack (Crack was removed via grinding).
